Preserving History, Ensuring Safety

Creative Seismic Strengthening Solutions at Historic Benson Polytechnic

Kevin J. Nadolny, PE, SE

- Client: PPS
- Architect: Bassetti Architects
- Contractor: Andersen Construction
- Structural Engineer: KPFF
- Building Area: 386,600 SF
- Total Project Cost: \$320 million
- 10 Buildings (6 existing)
- Bike Shelter
- Retrofit of a Radio Tower

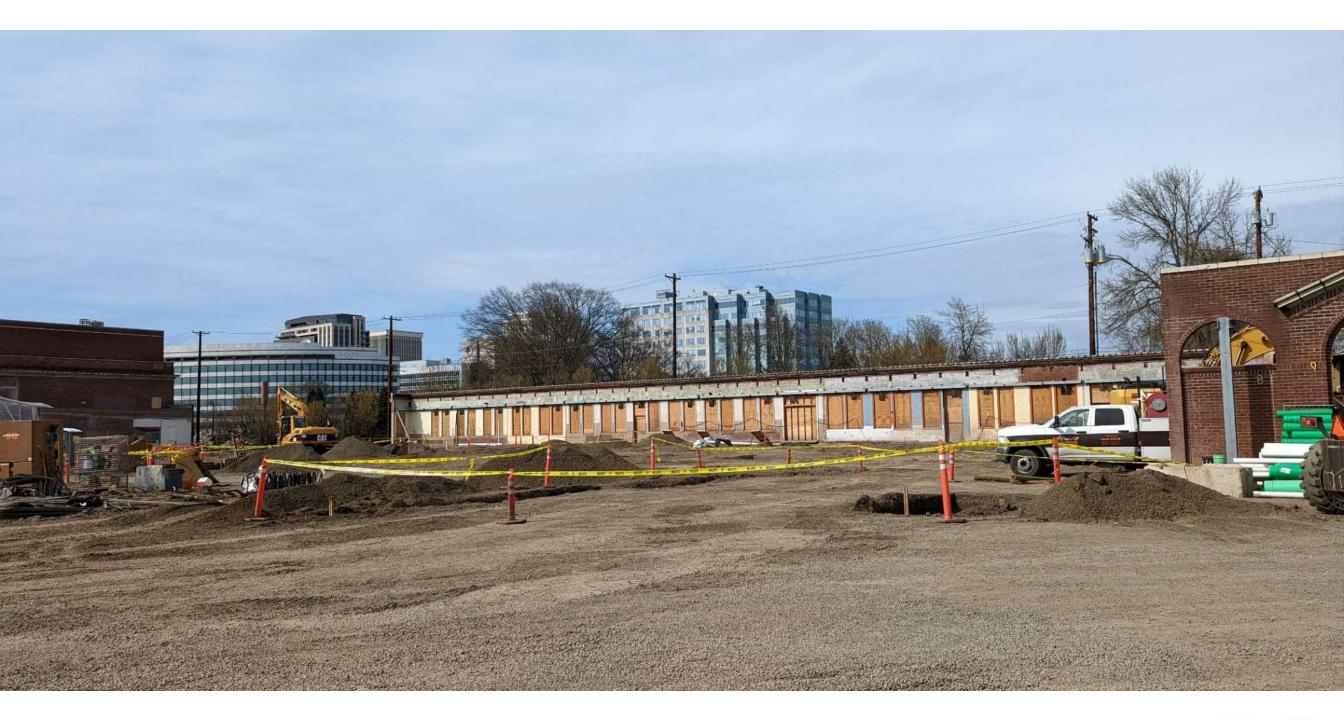
Mass Demolition & Site Work | kpff

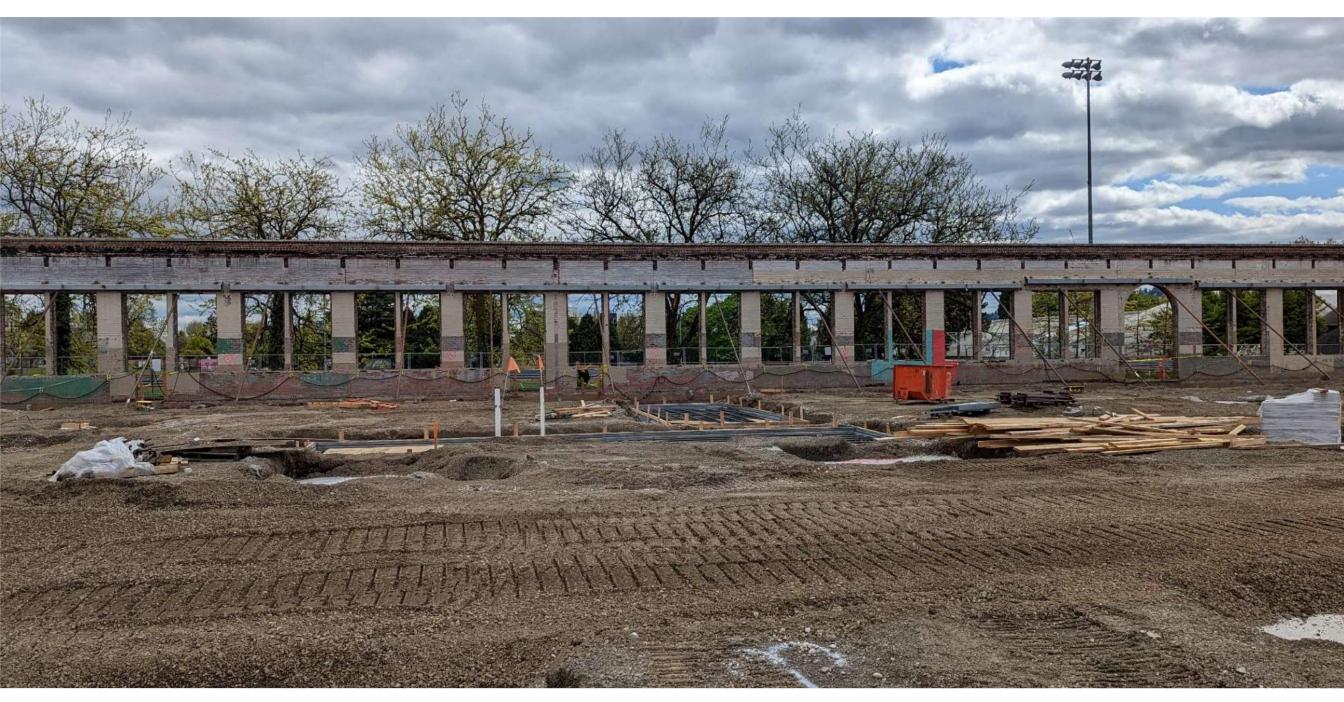
Building C & H Foundations | kpff

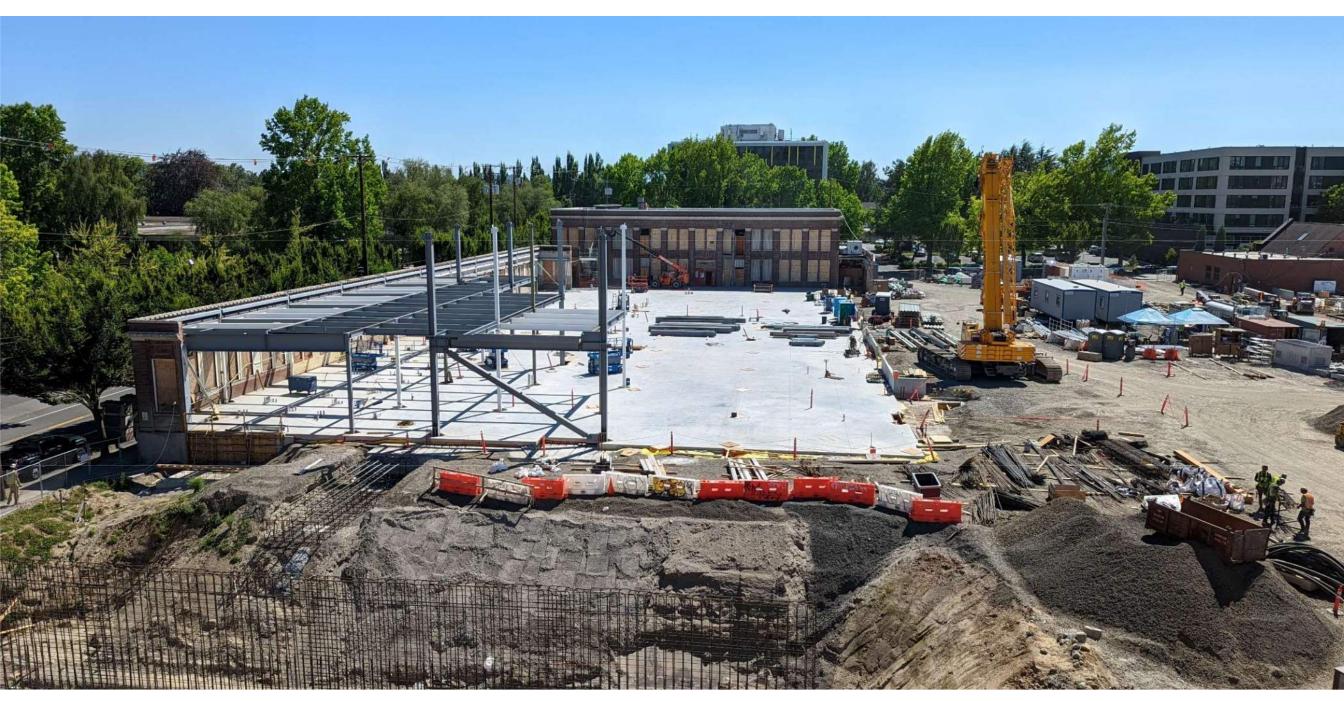
Building C & H Steel Erection | kpff

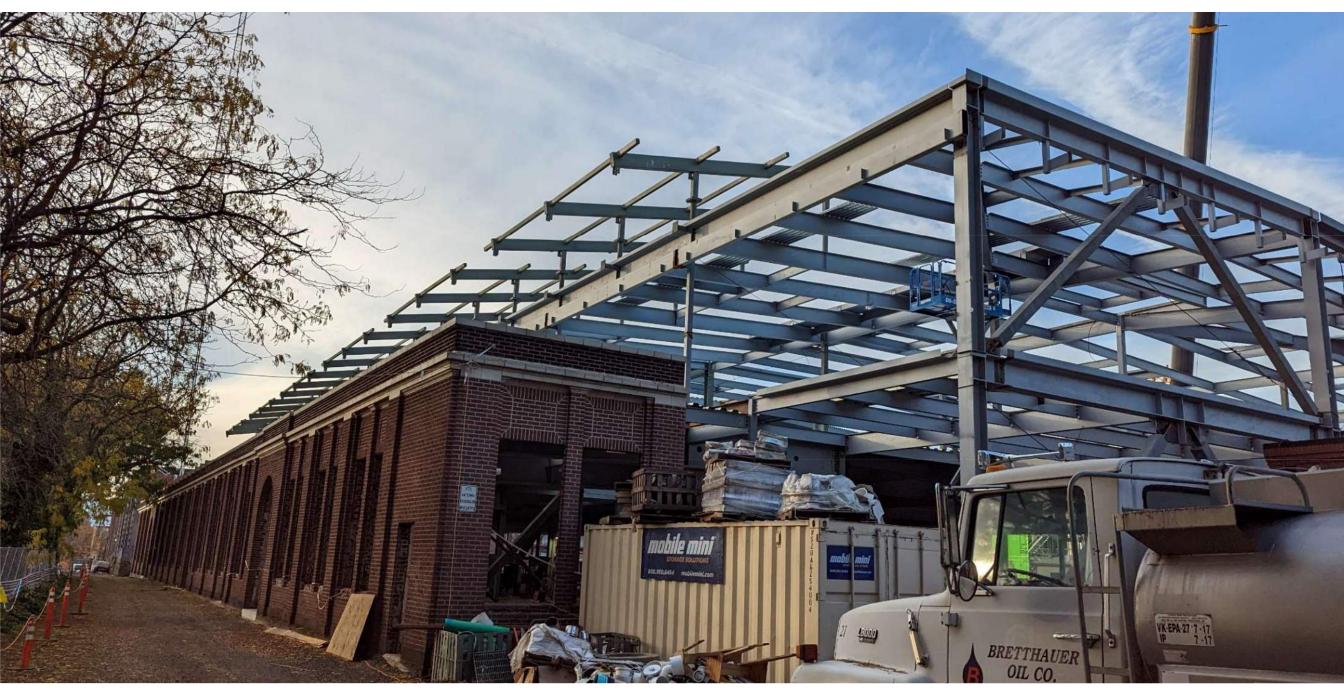
Building C & H – Steel Erection

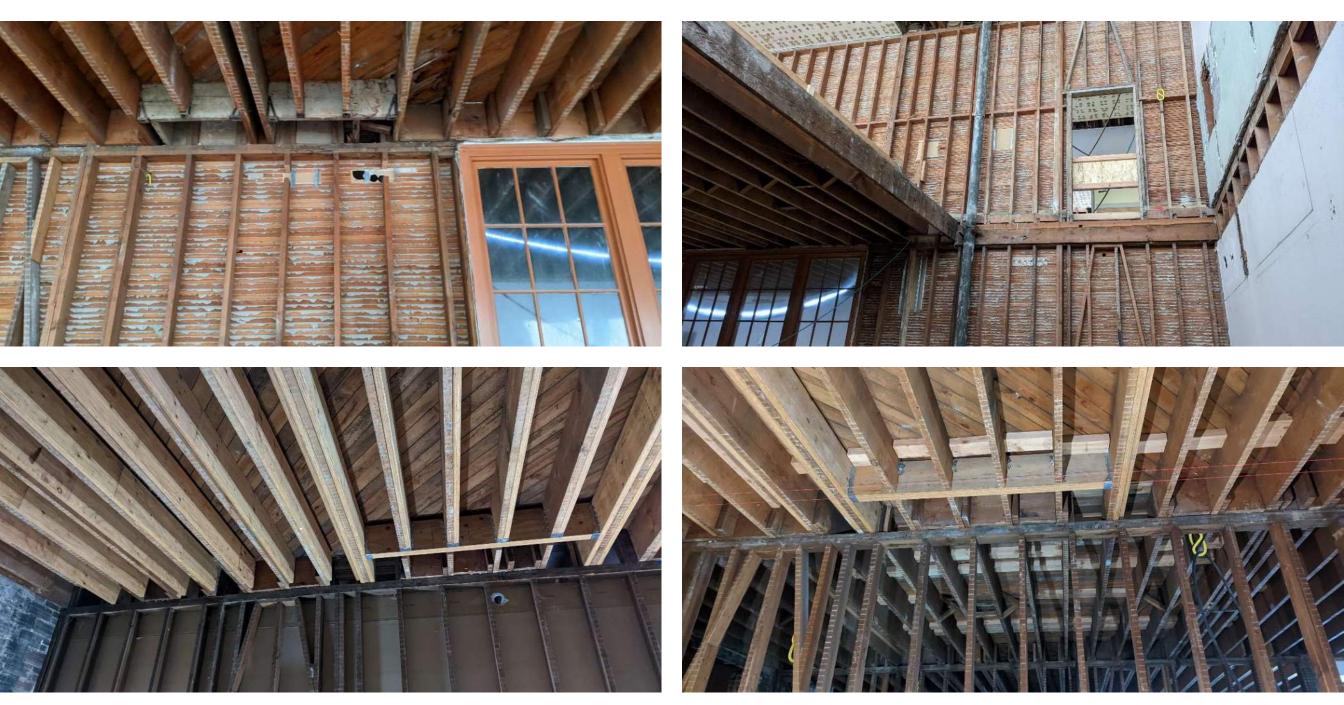
Building E – Wood Gravity Framing Alterations

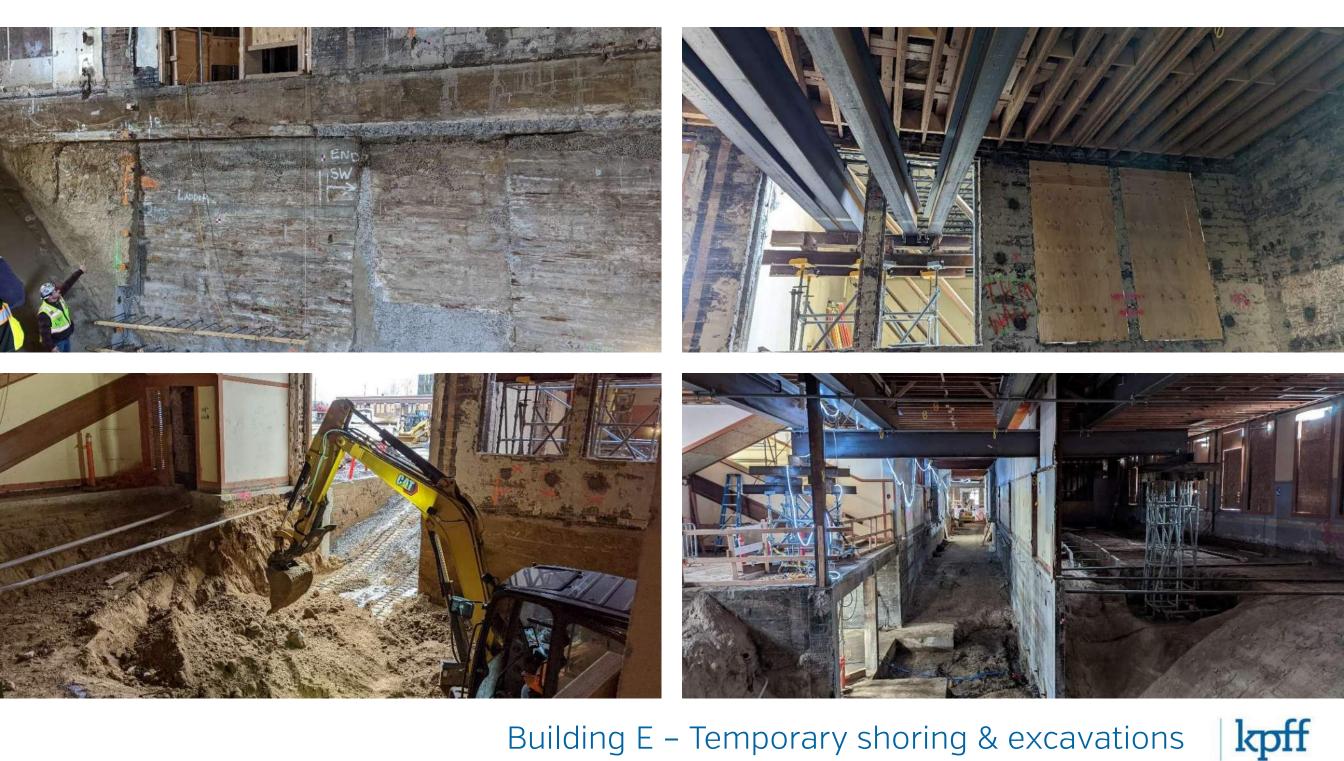
Building E – Temporary shoring & excavations

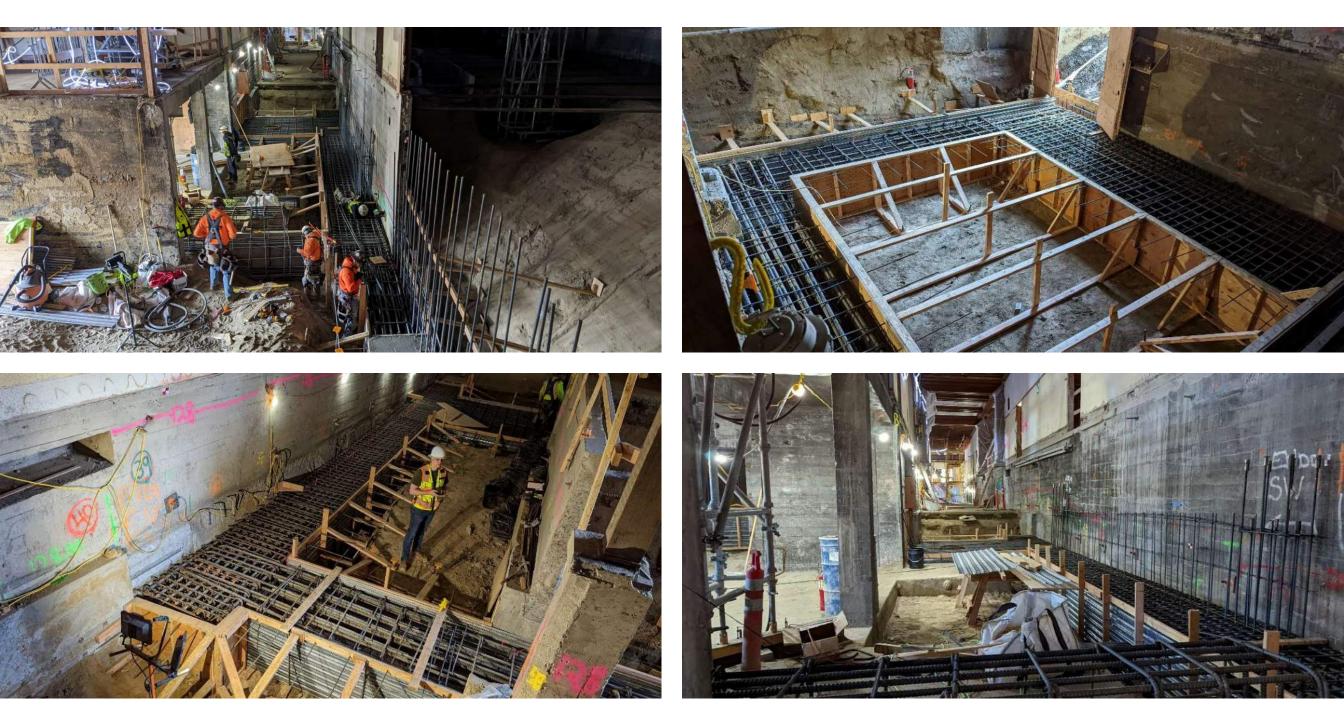
Building E – Shear Wall Foundations

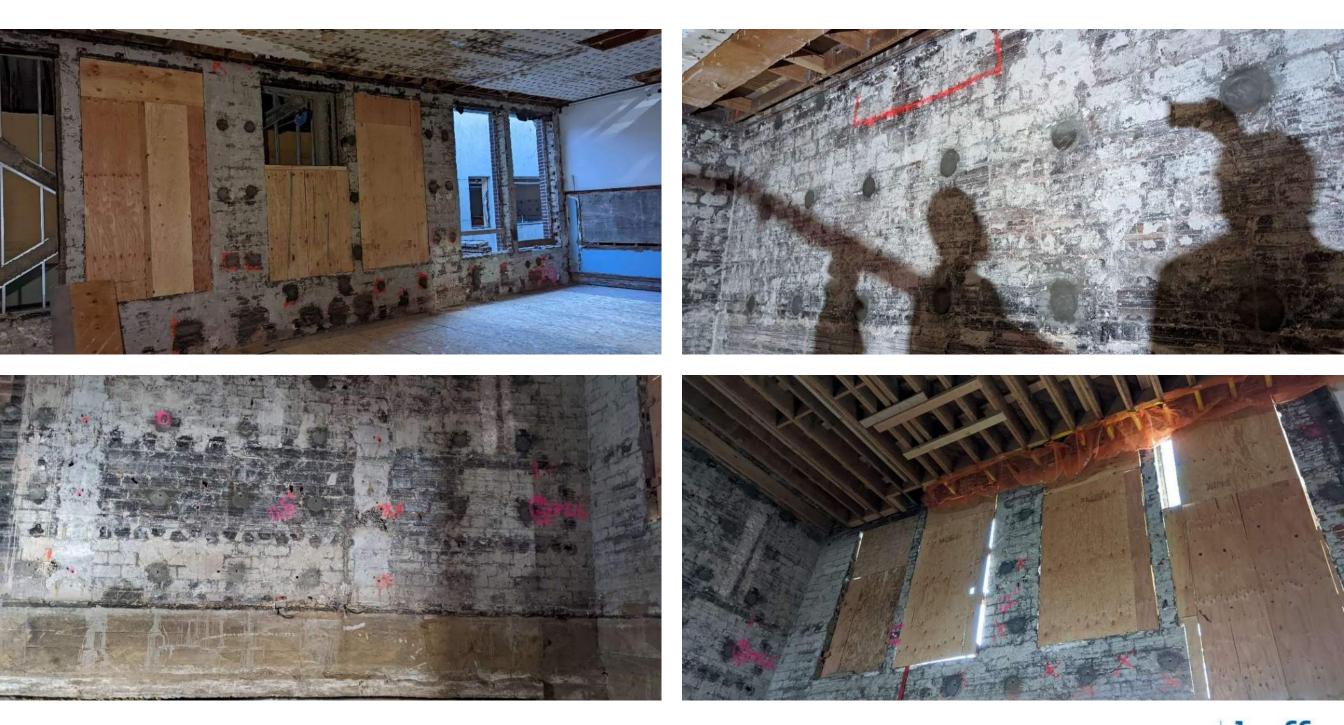
Building E – Shear Wall Anchors to (E) Walls

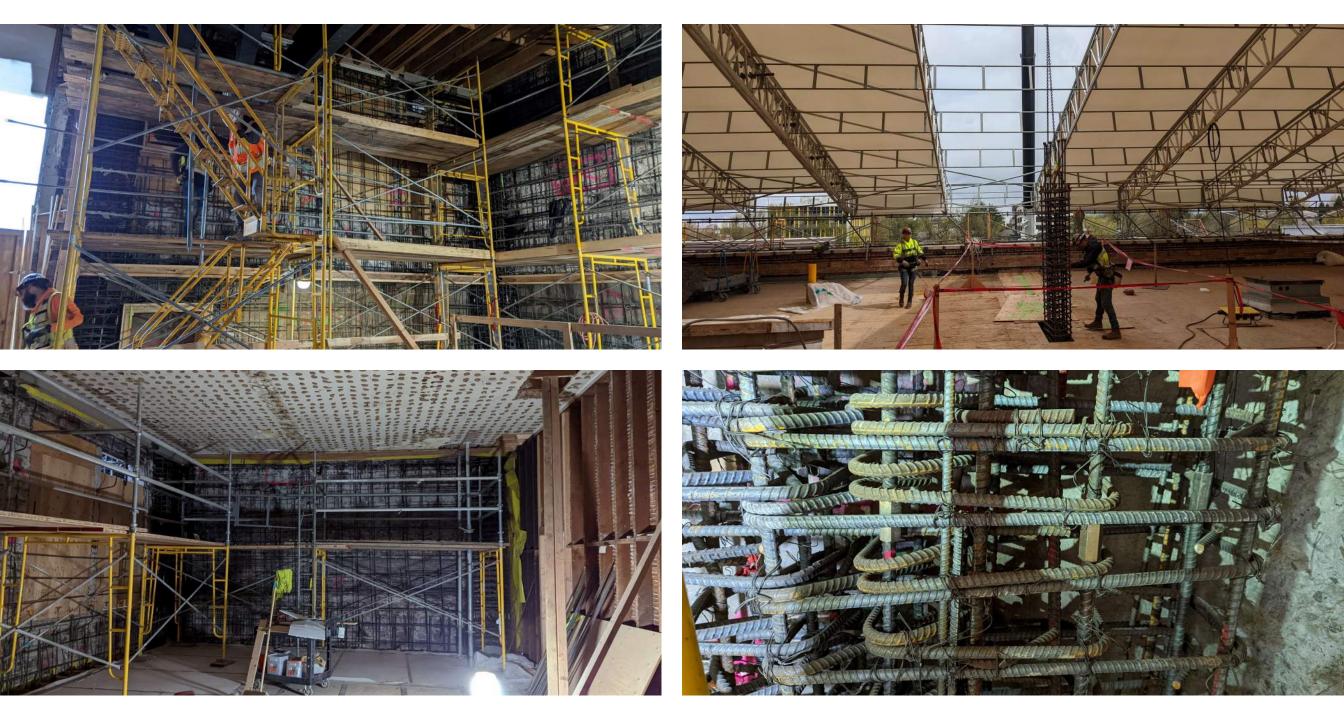
Building E – Concrete Shear Walls w/ prefab boundaries

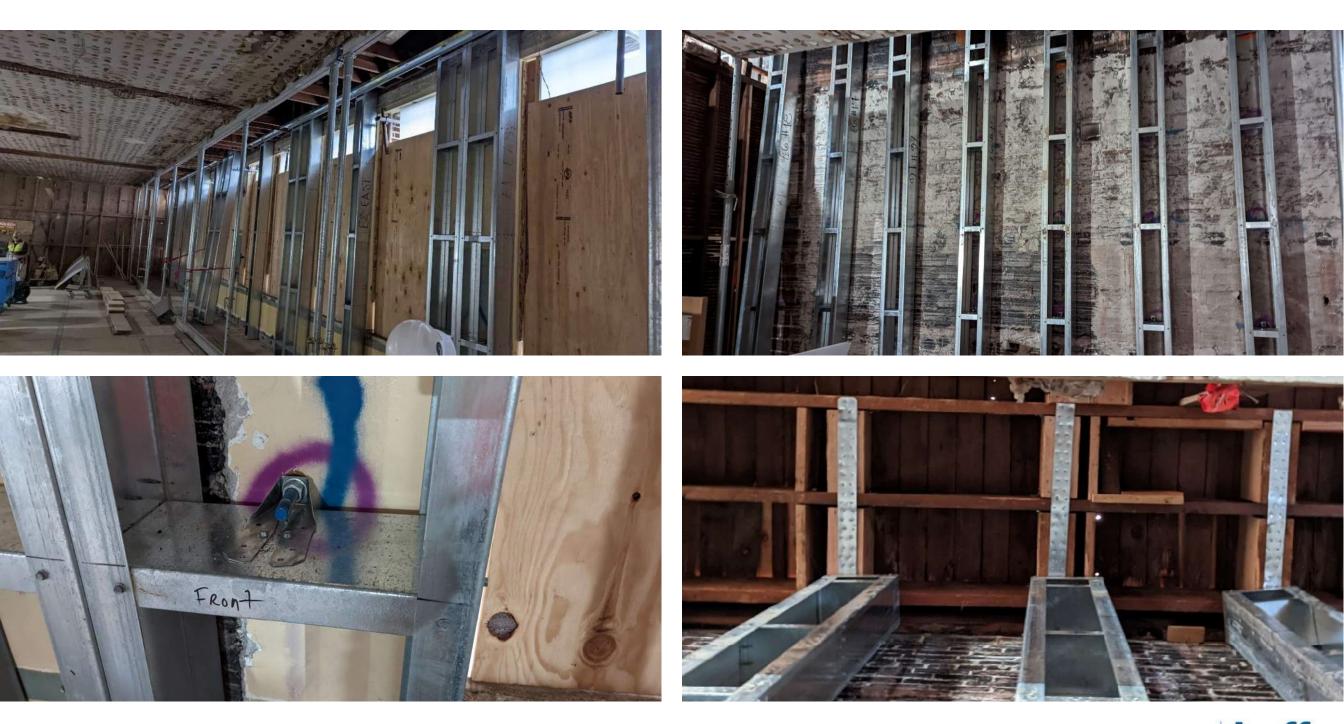
Building E – CFS Strongbacks at URM | kpff

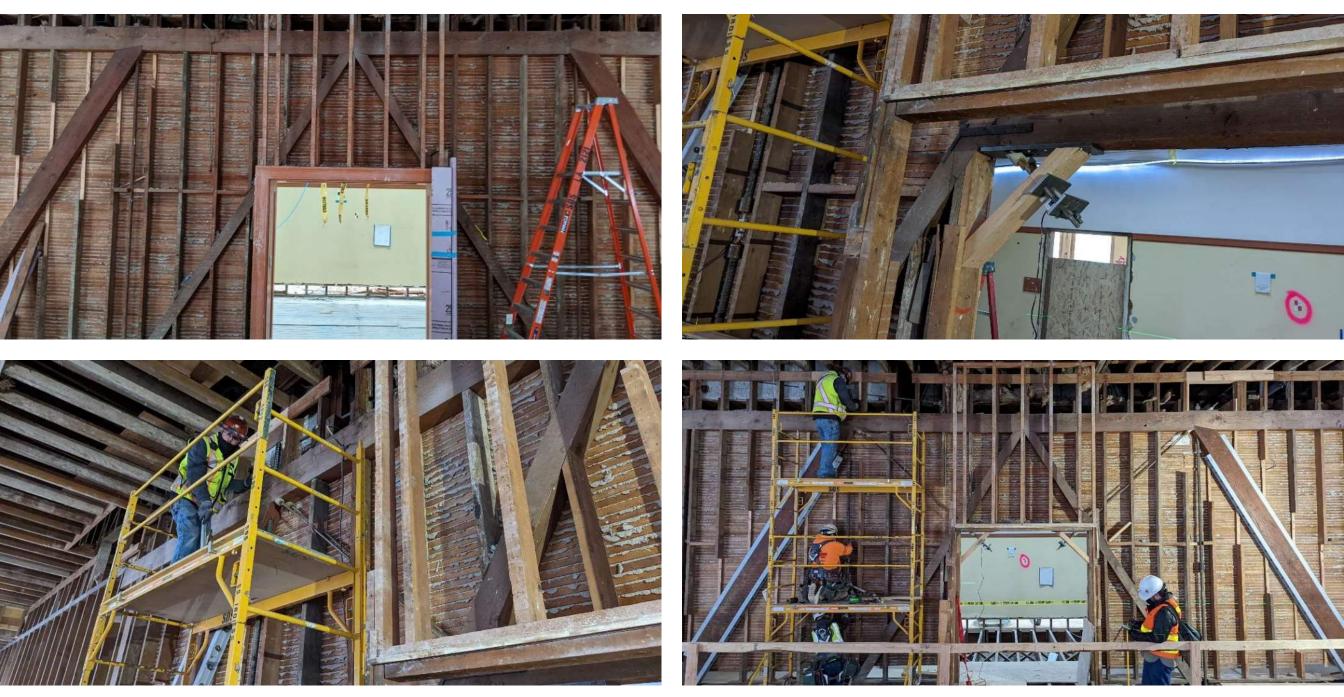
Building E – Story-Deep Truss Retrofit | kpff

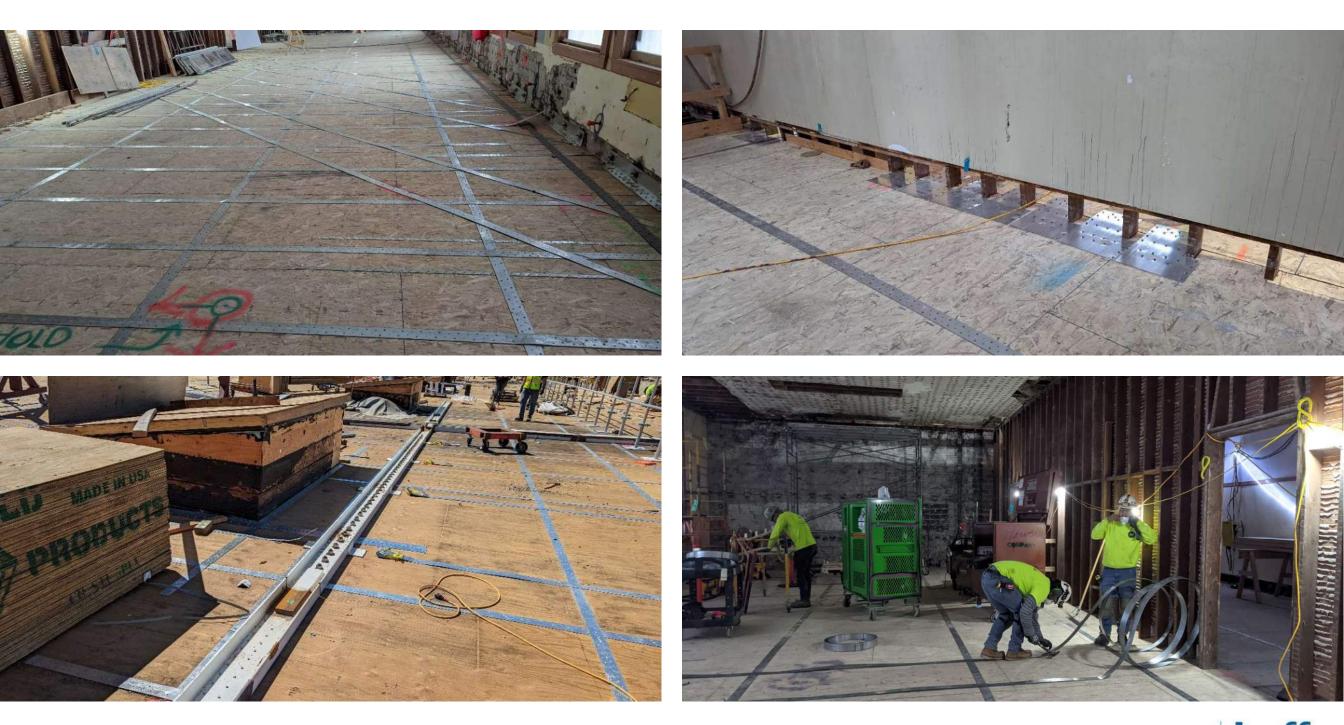
Building E – Wood Diaphragm Details | kpff

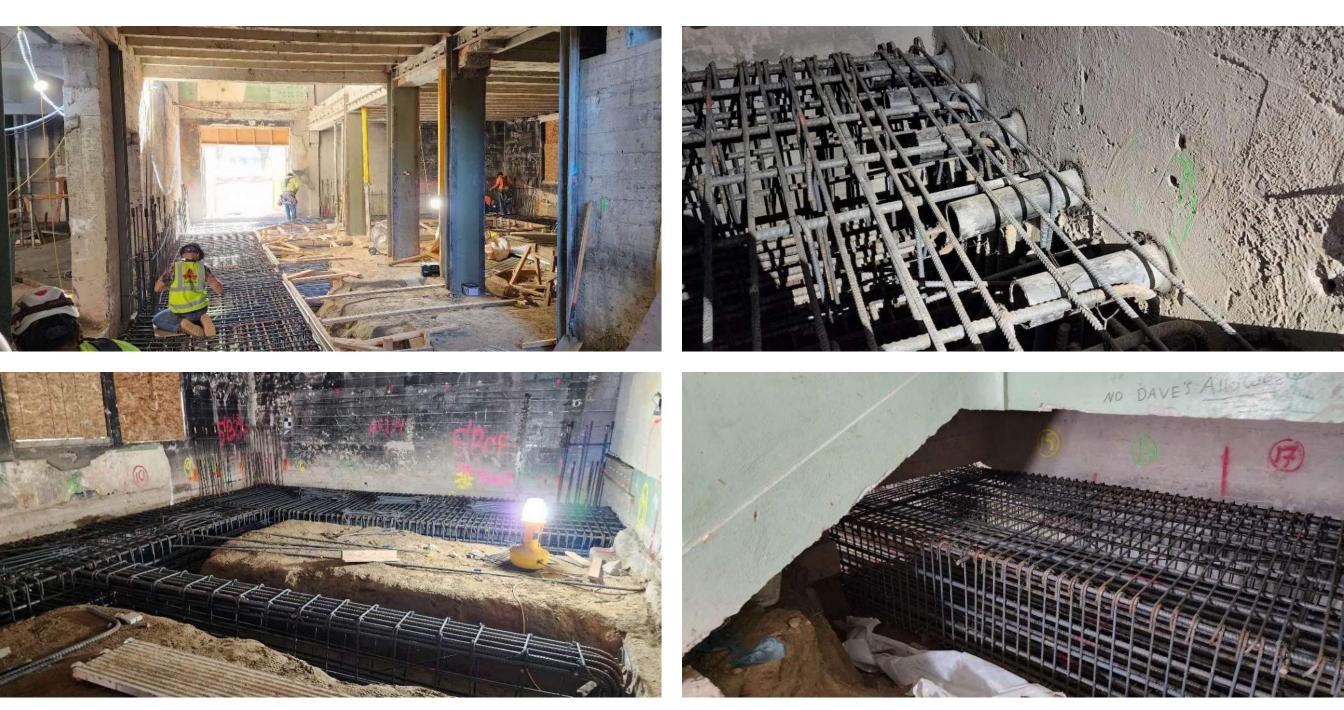
Building G1 – Shear Wall Foundations

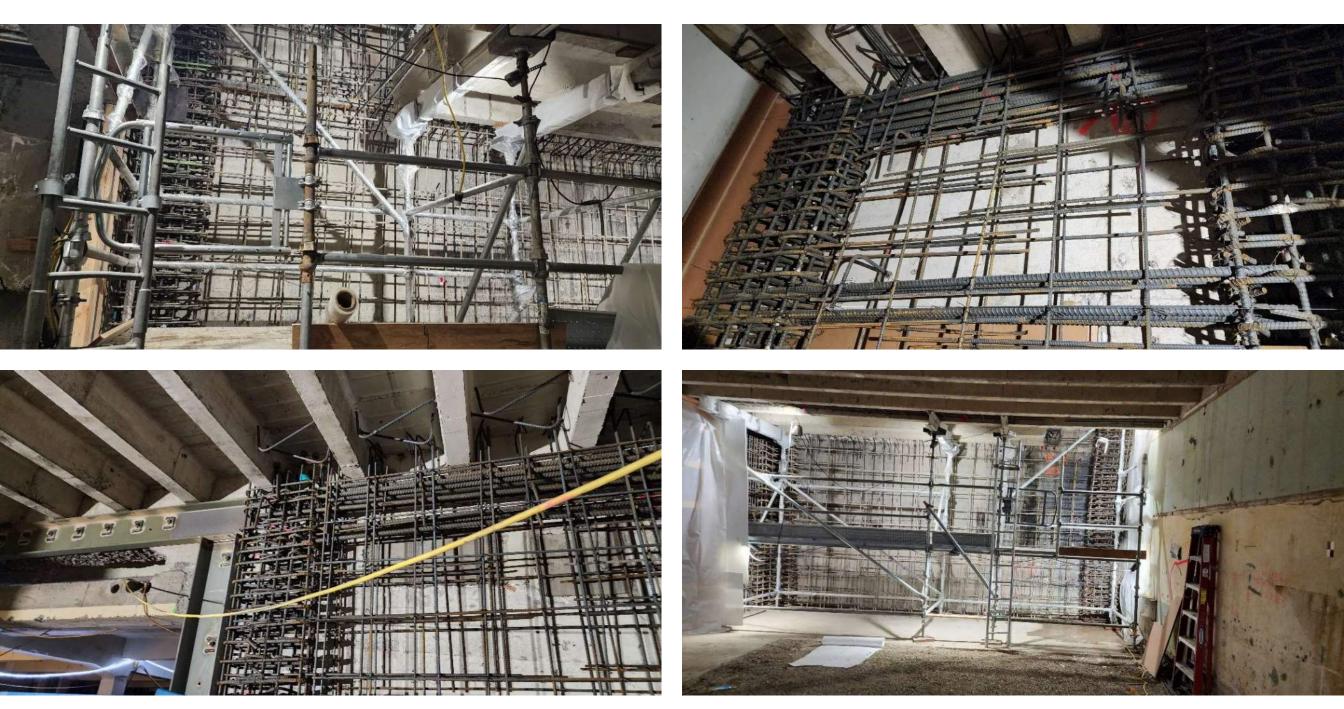
Building G1 – Concrete Shear Walls

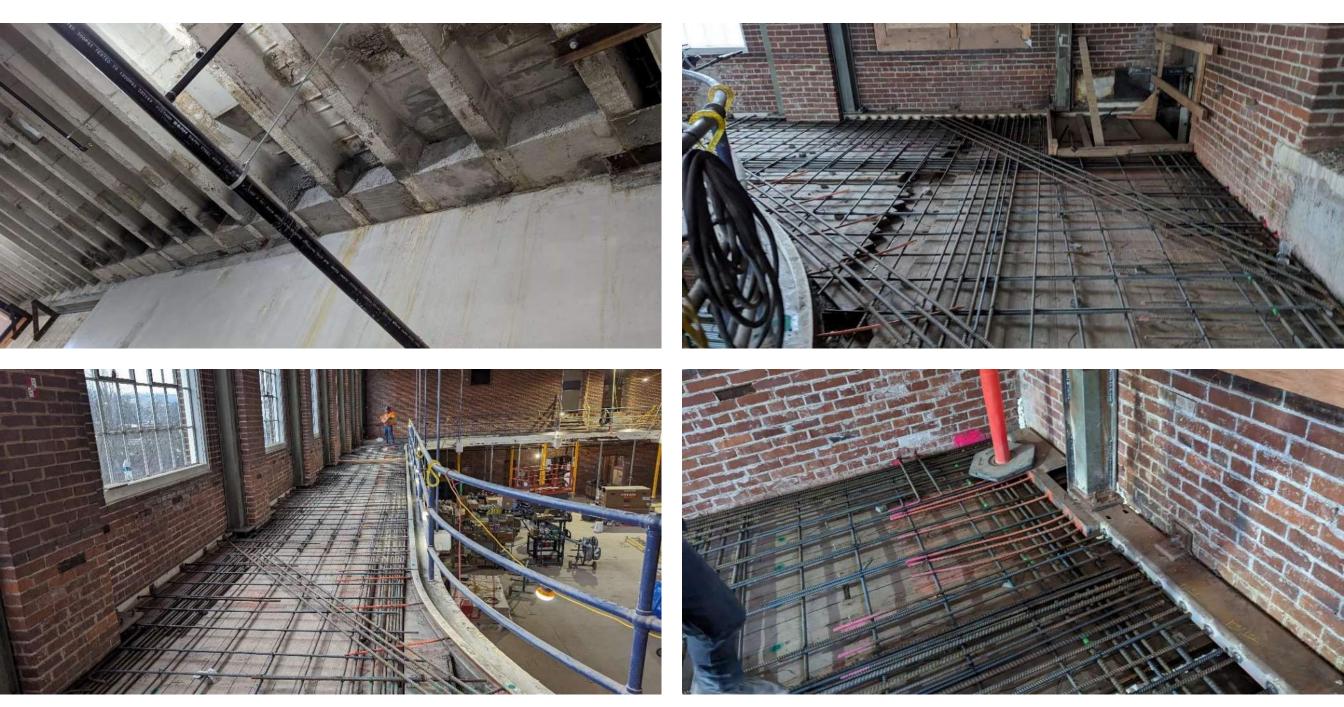
Building G1 – Diaphragms & Collectors | kpff

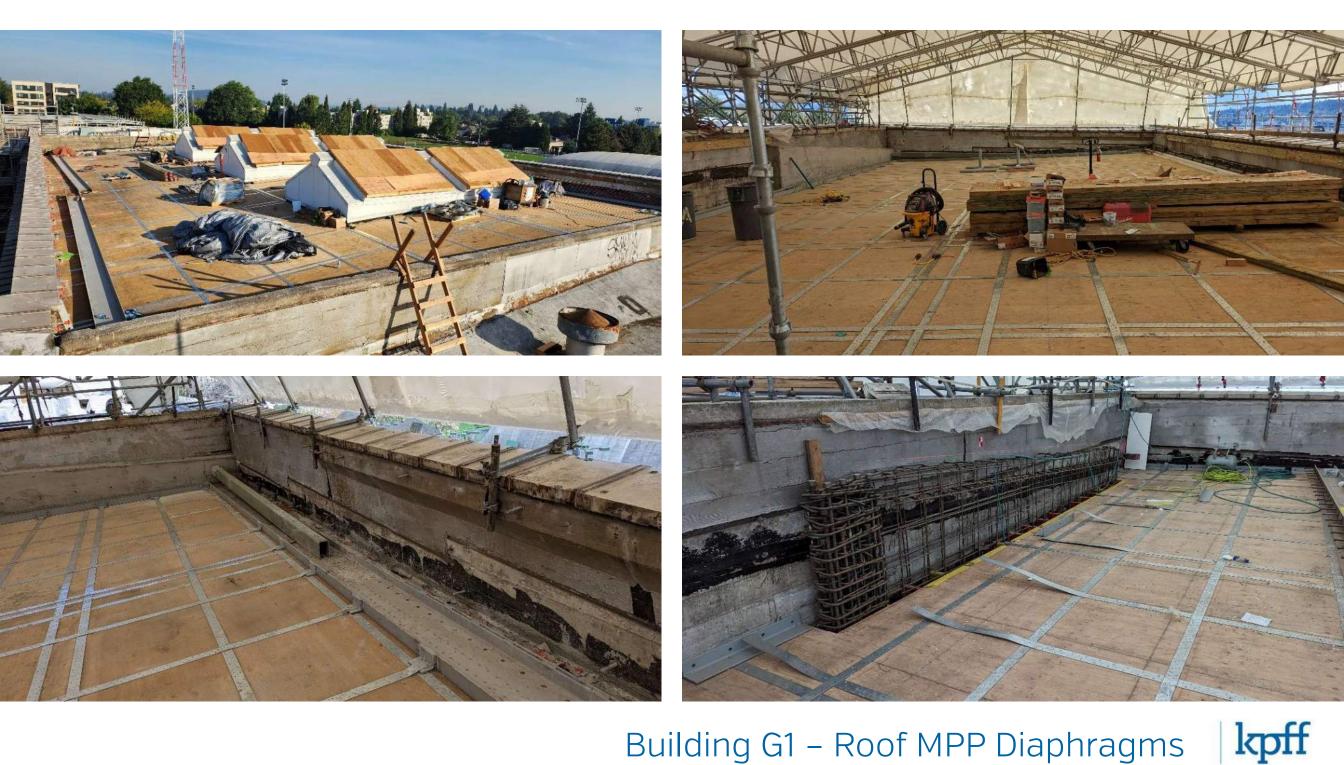
Building G1 – Roof MPP Diaphragms

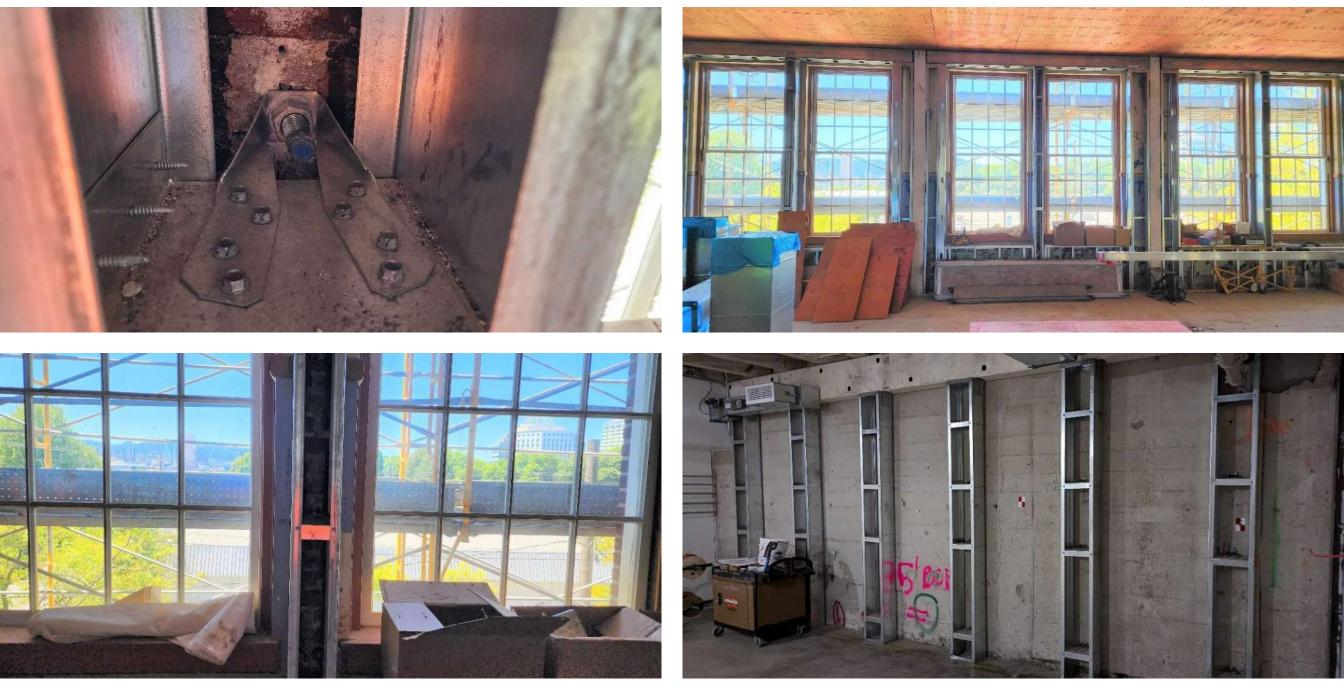
Building G1 – Strongbacks at Classroom Wings

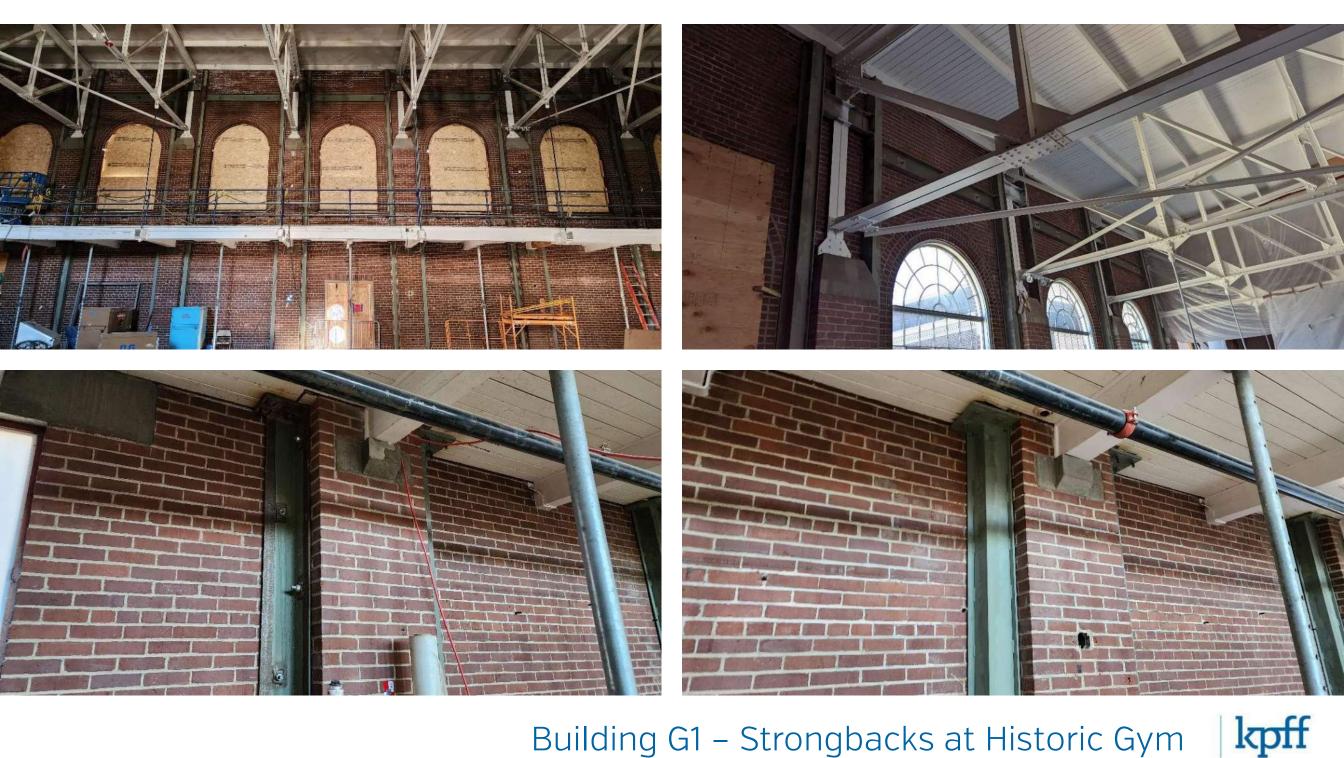
Building G1 – Strongbacks at Historic Gym

Building G1 – Strongbacks and Existing Trusses

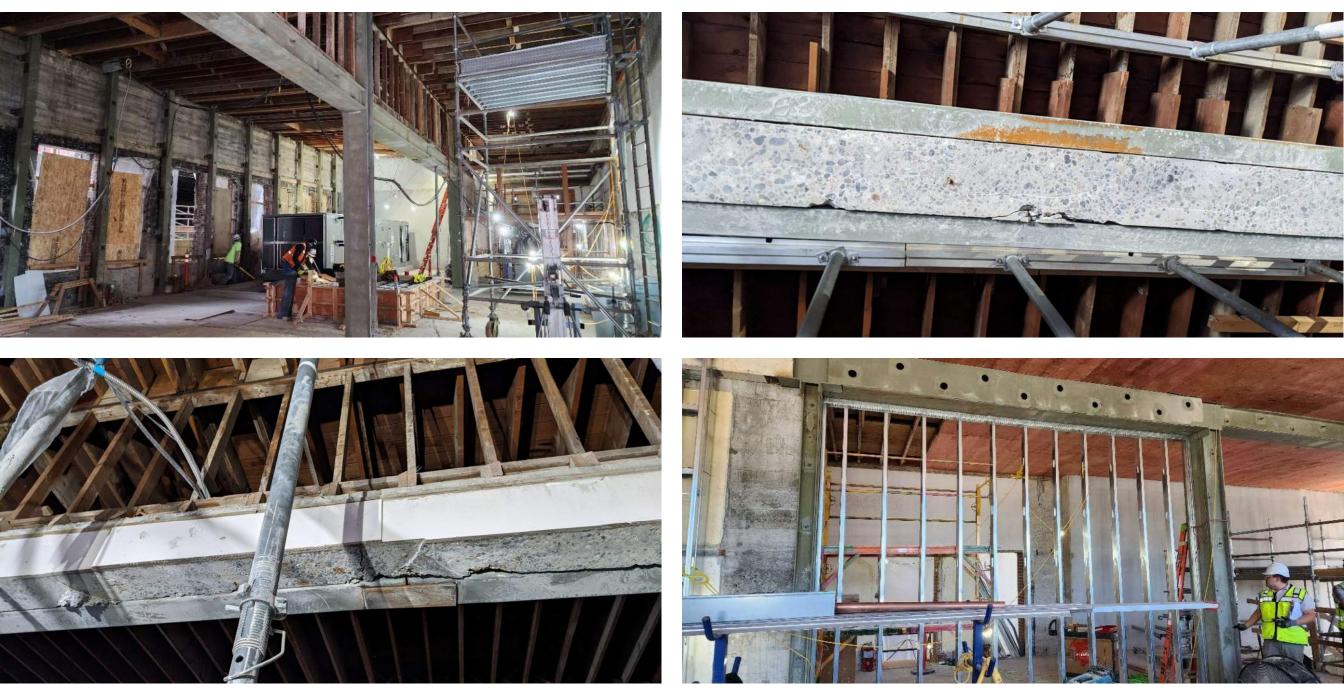
Building G1 – Unreinforced Wall Demolition

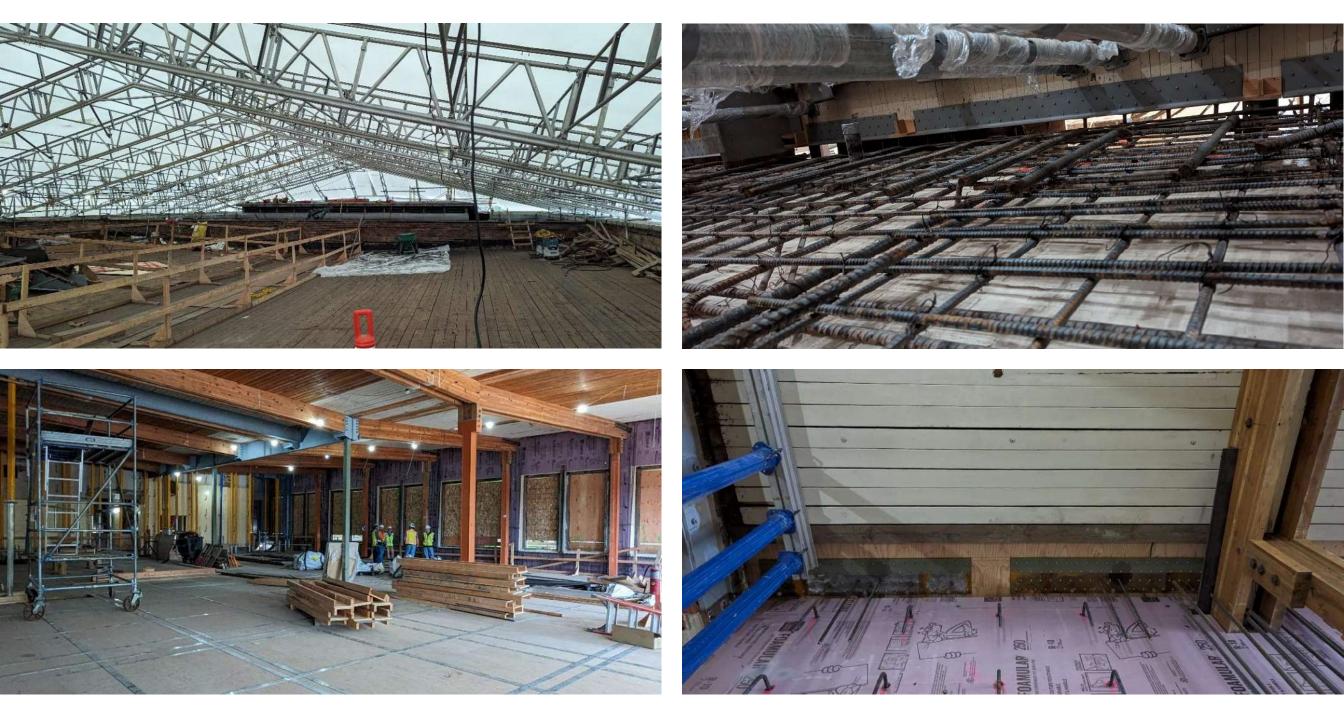
Building D – MPP Diaphragms

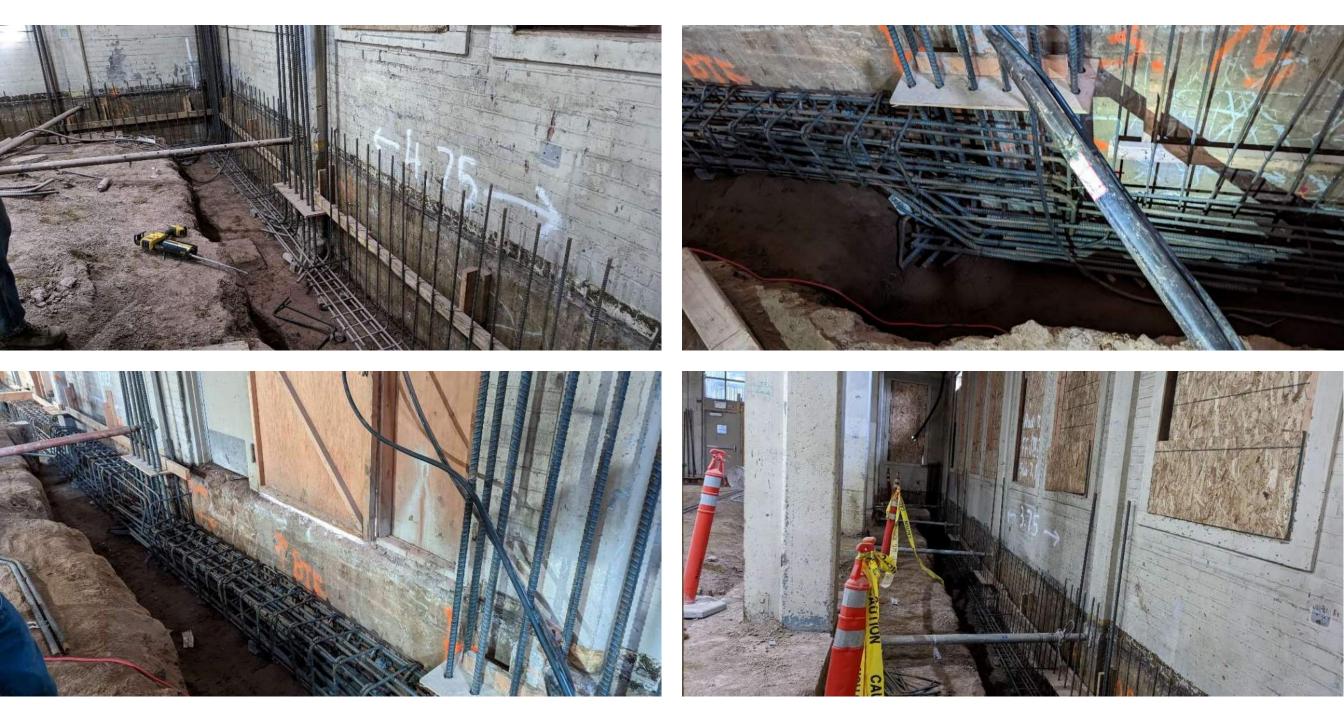
Building D – Continuous Shear Wall Strip Foundations

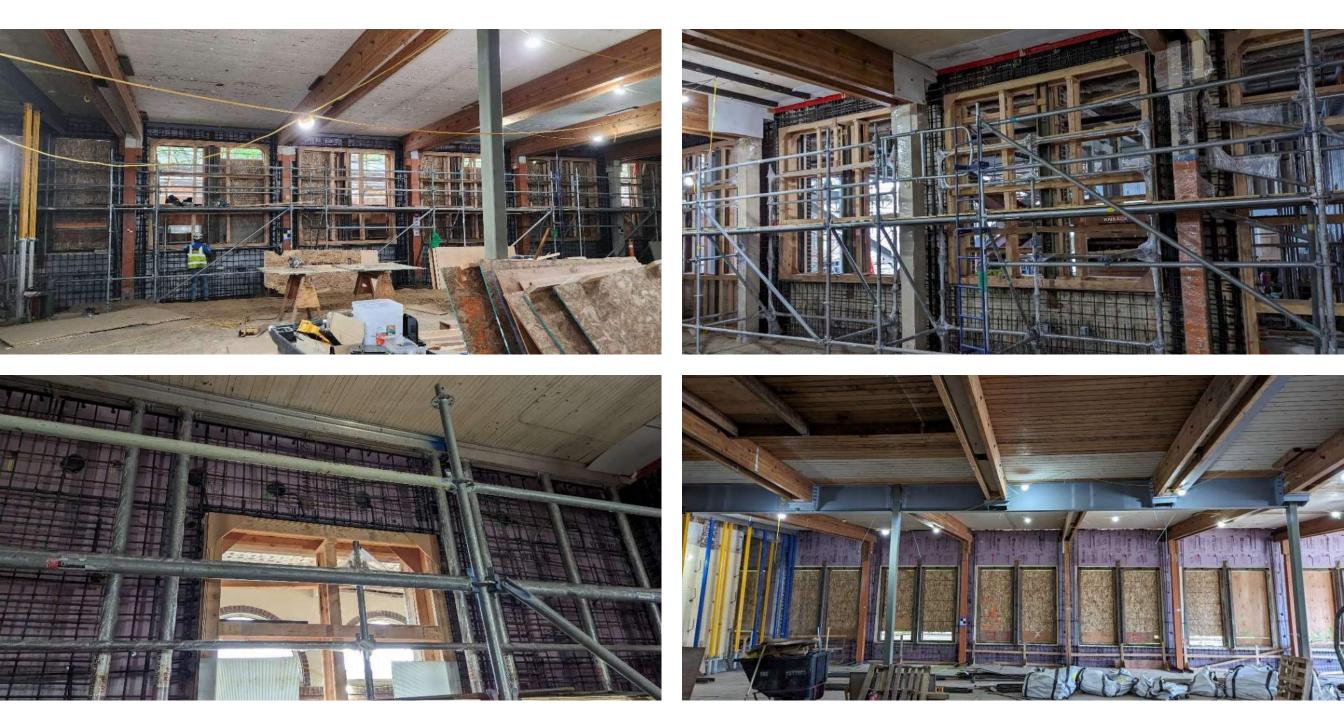
Building D – Continuous Shotcrete Shear Walls w/ Insulation

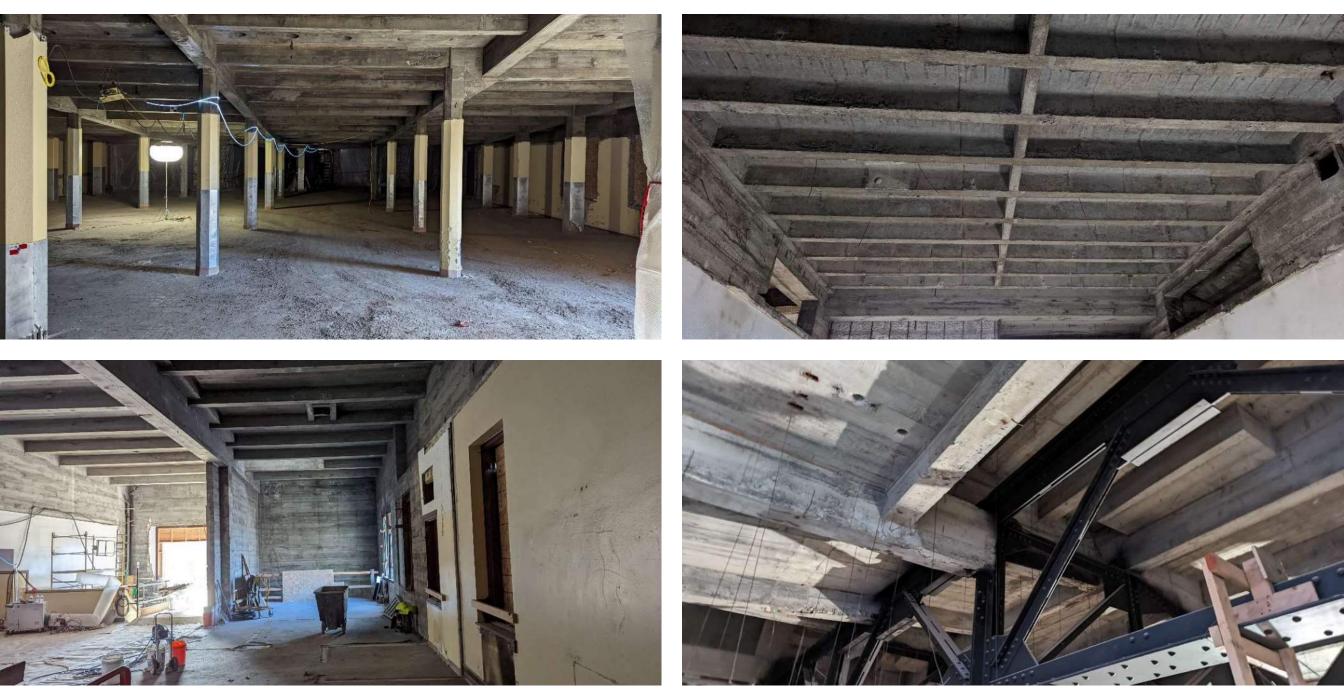
Building A – Existing Structure After Demolition
