Preserving History, Ensuring Safety

Creative Seismic Strengthening Solutions at Historic Benson Polytechnic

Kevin J. Nadolny, PE, SE

- Client: PPS
- Architect: Bassetti Architects
- Contractor: Andersen Construction
- Structural Engineer: KPFF
- Building Area: 386,600 SF
- Total Project Cost: \$320 million
- 10 Buildings (6 existing)
- Bike Shelter
- Retrofit of a Radio Tower

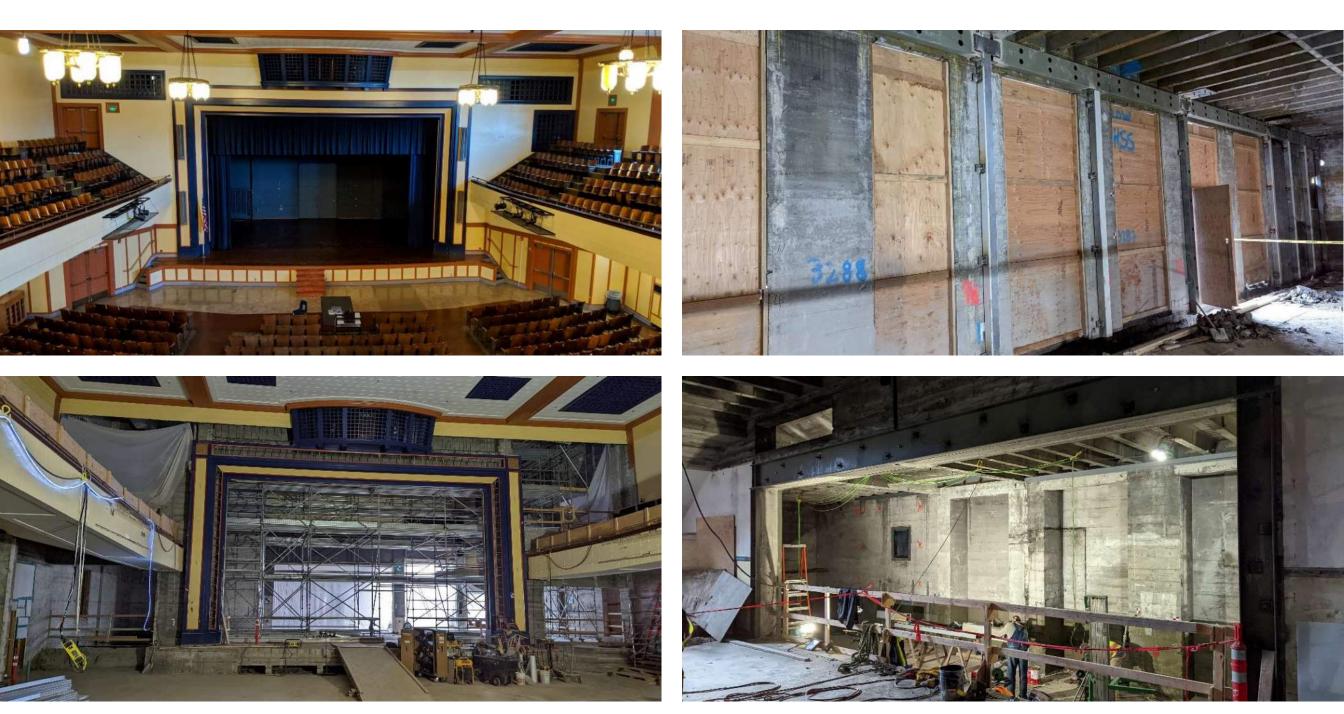
Building A – Strongbacks & Unreinforced Wall Demo

Building A – Strongbacks to Reduce OOP Demands on (E) Columns

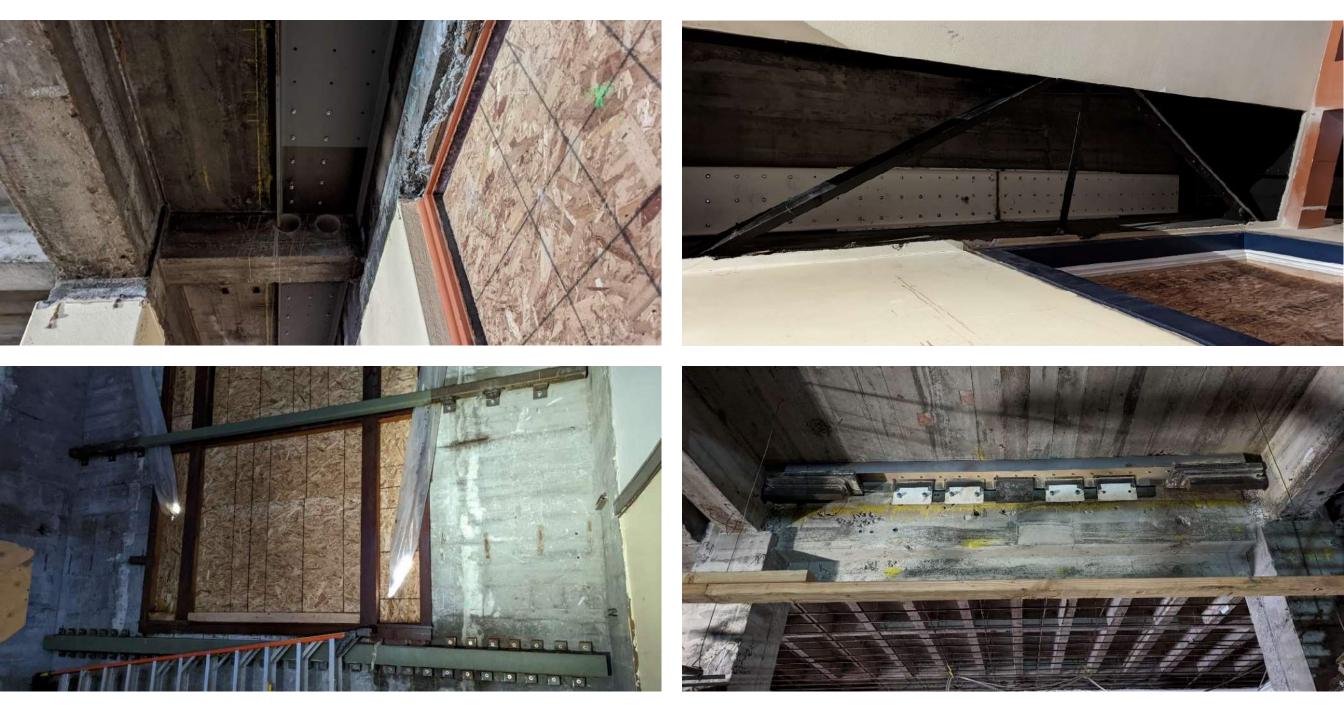
Building A – Collectors | kpff

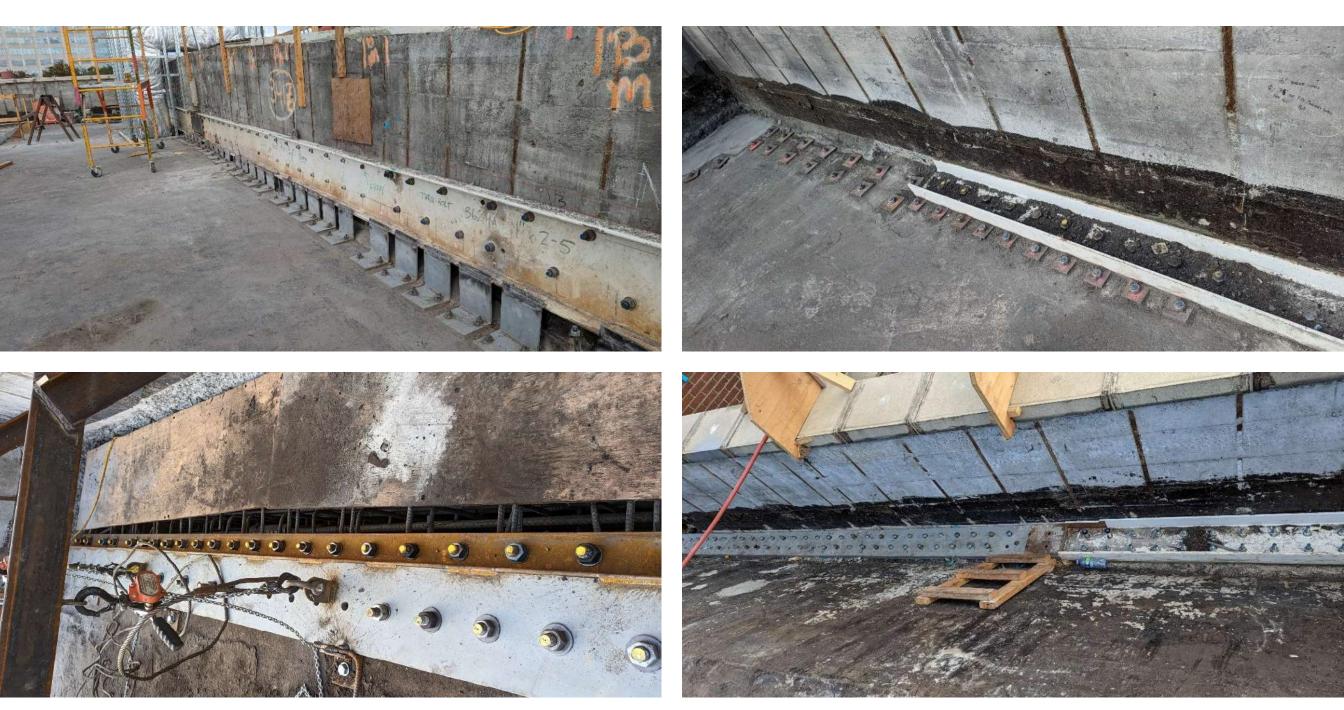
Building A – Roof Collectors | kpff

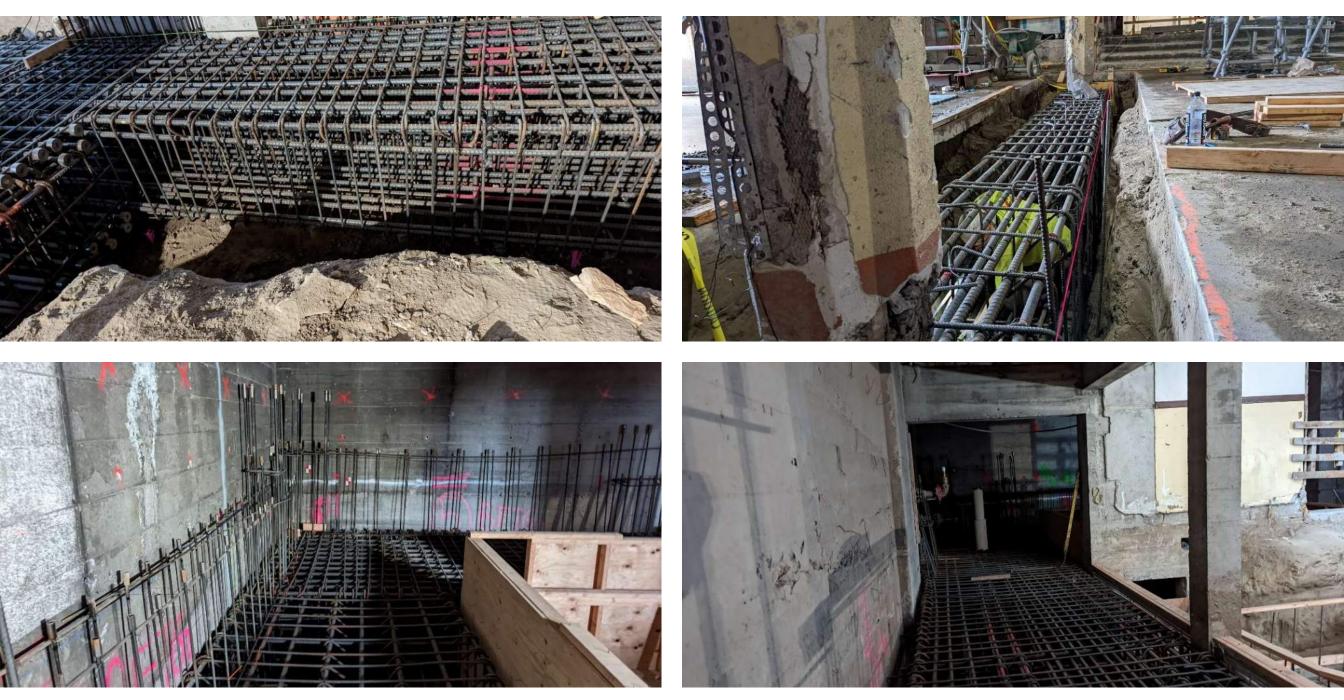
Building A – Shear Wall Foundations

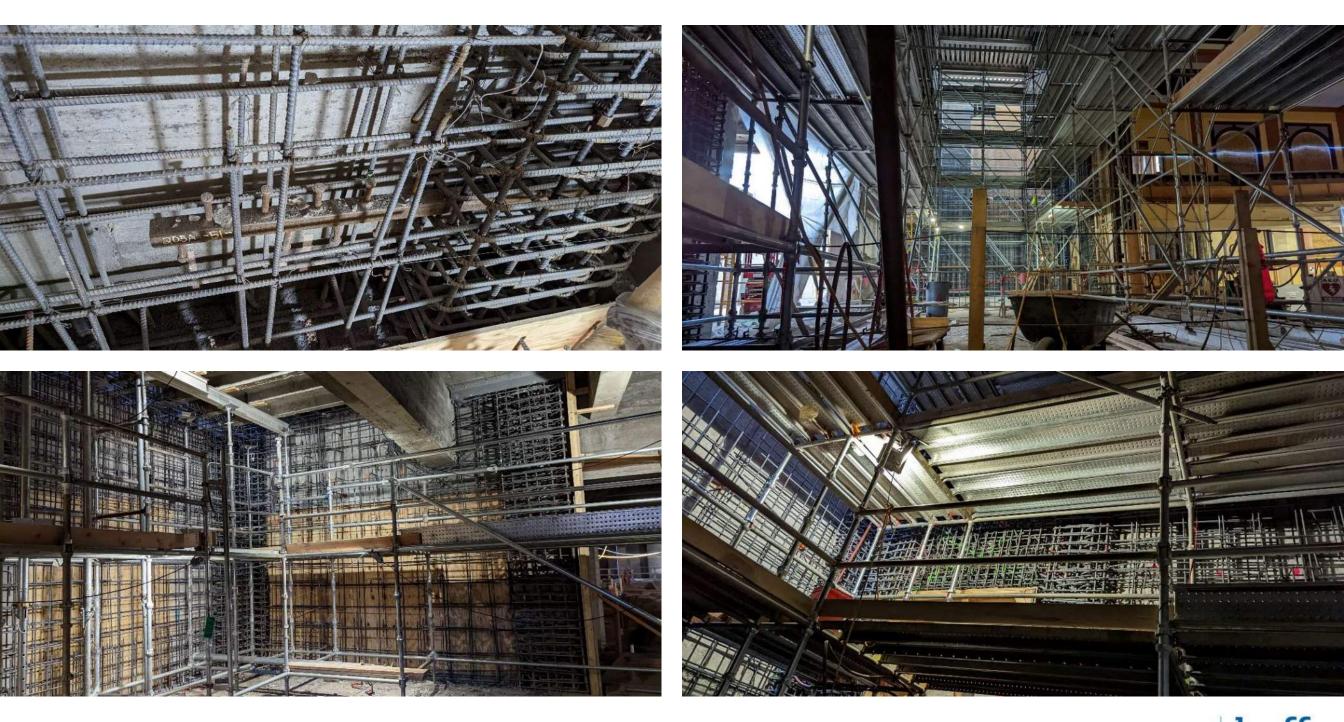
Building A – Shear Walls | kpff

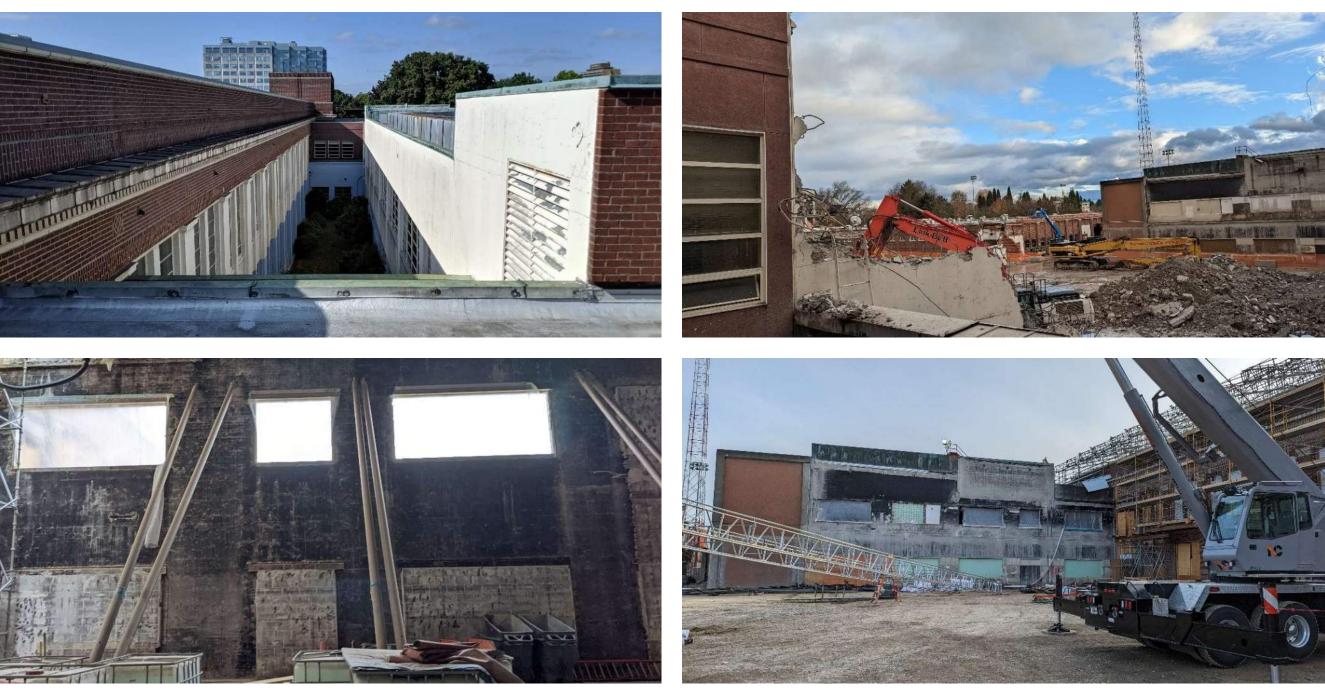
Building G2 – 1953 Wall Salvage

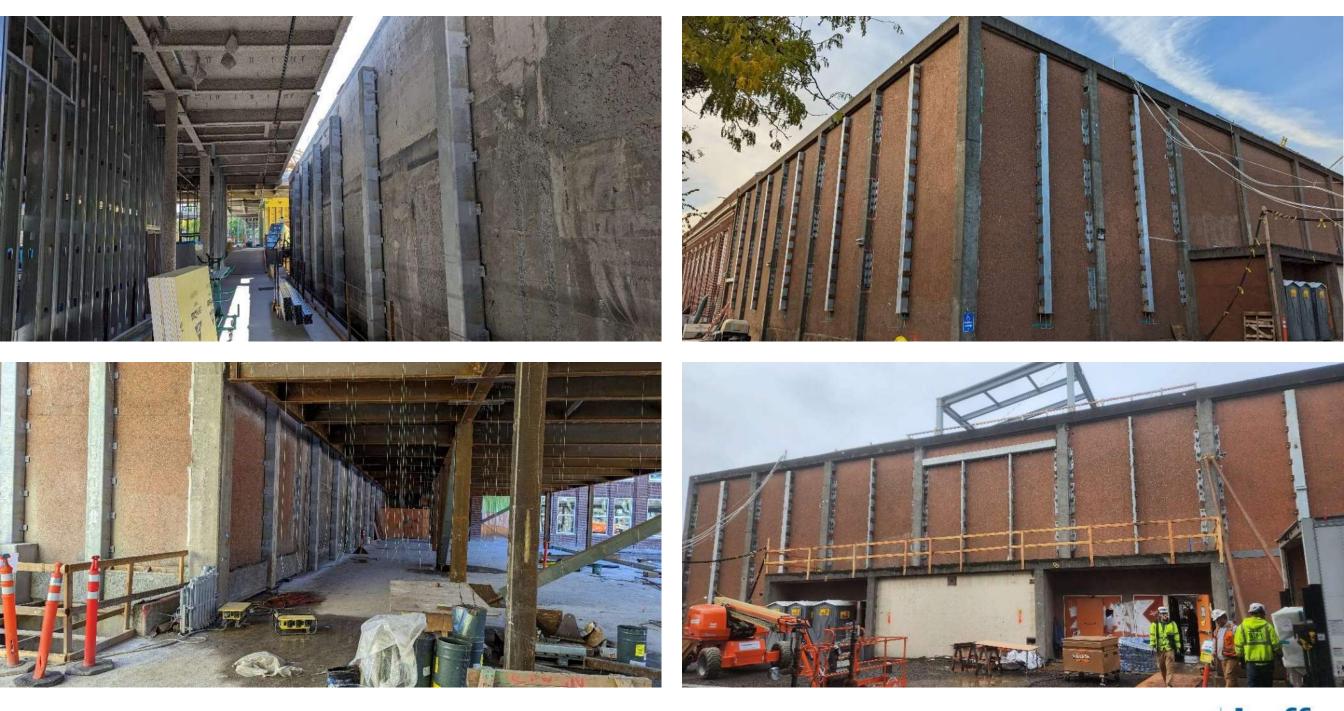
Building G2 – Strongbacks & Wall Ties | kpff

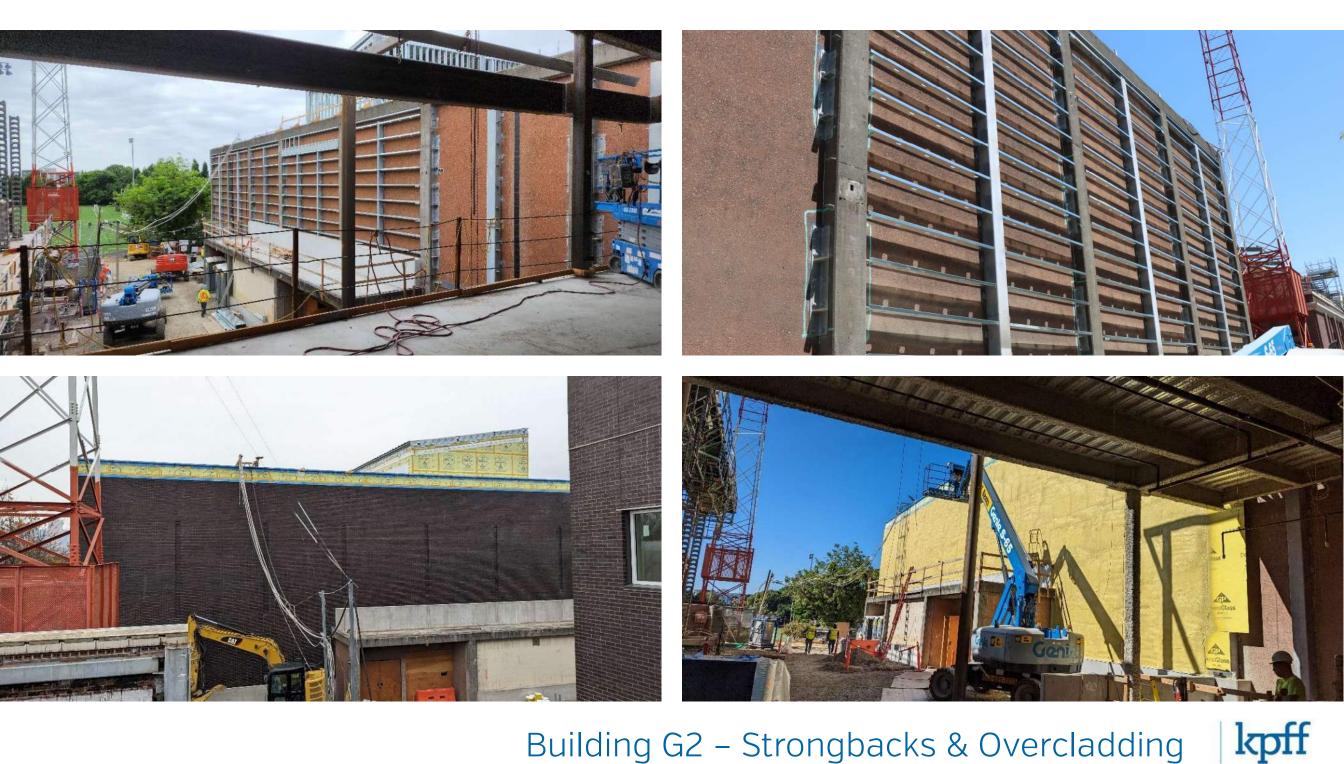
Building G2 – Strongbacks & Overcladding

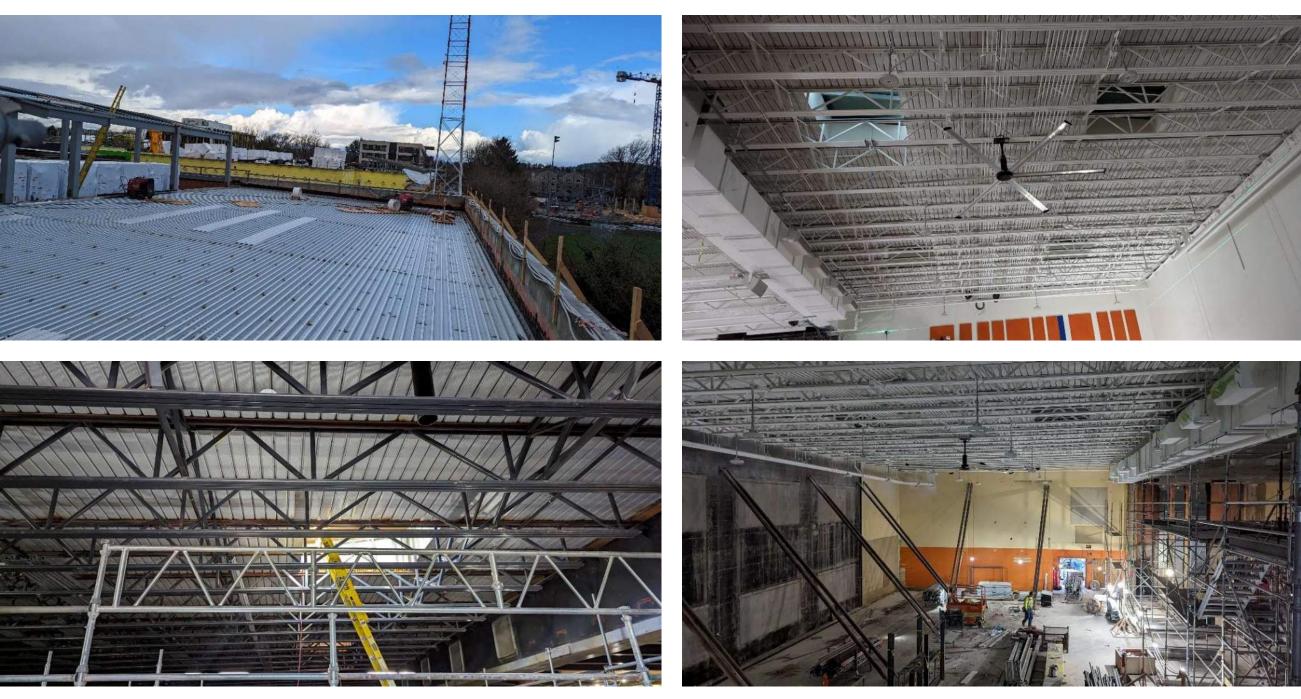
Building G2 – Roof Diaphragm
